KANSAS CORPORATION COMMISSION

Remediation Site Status Report

2015

**Abandoned Oil and Gas Well / Remediation Site Fund
Remediation Sites
Status Report**

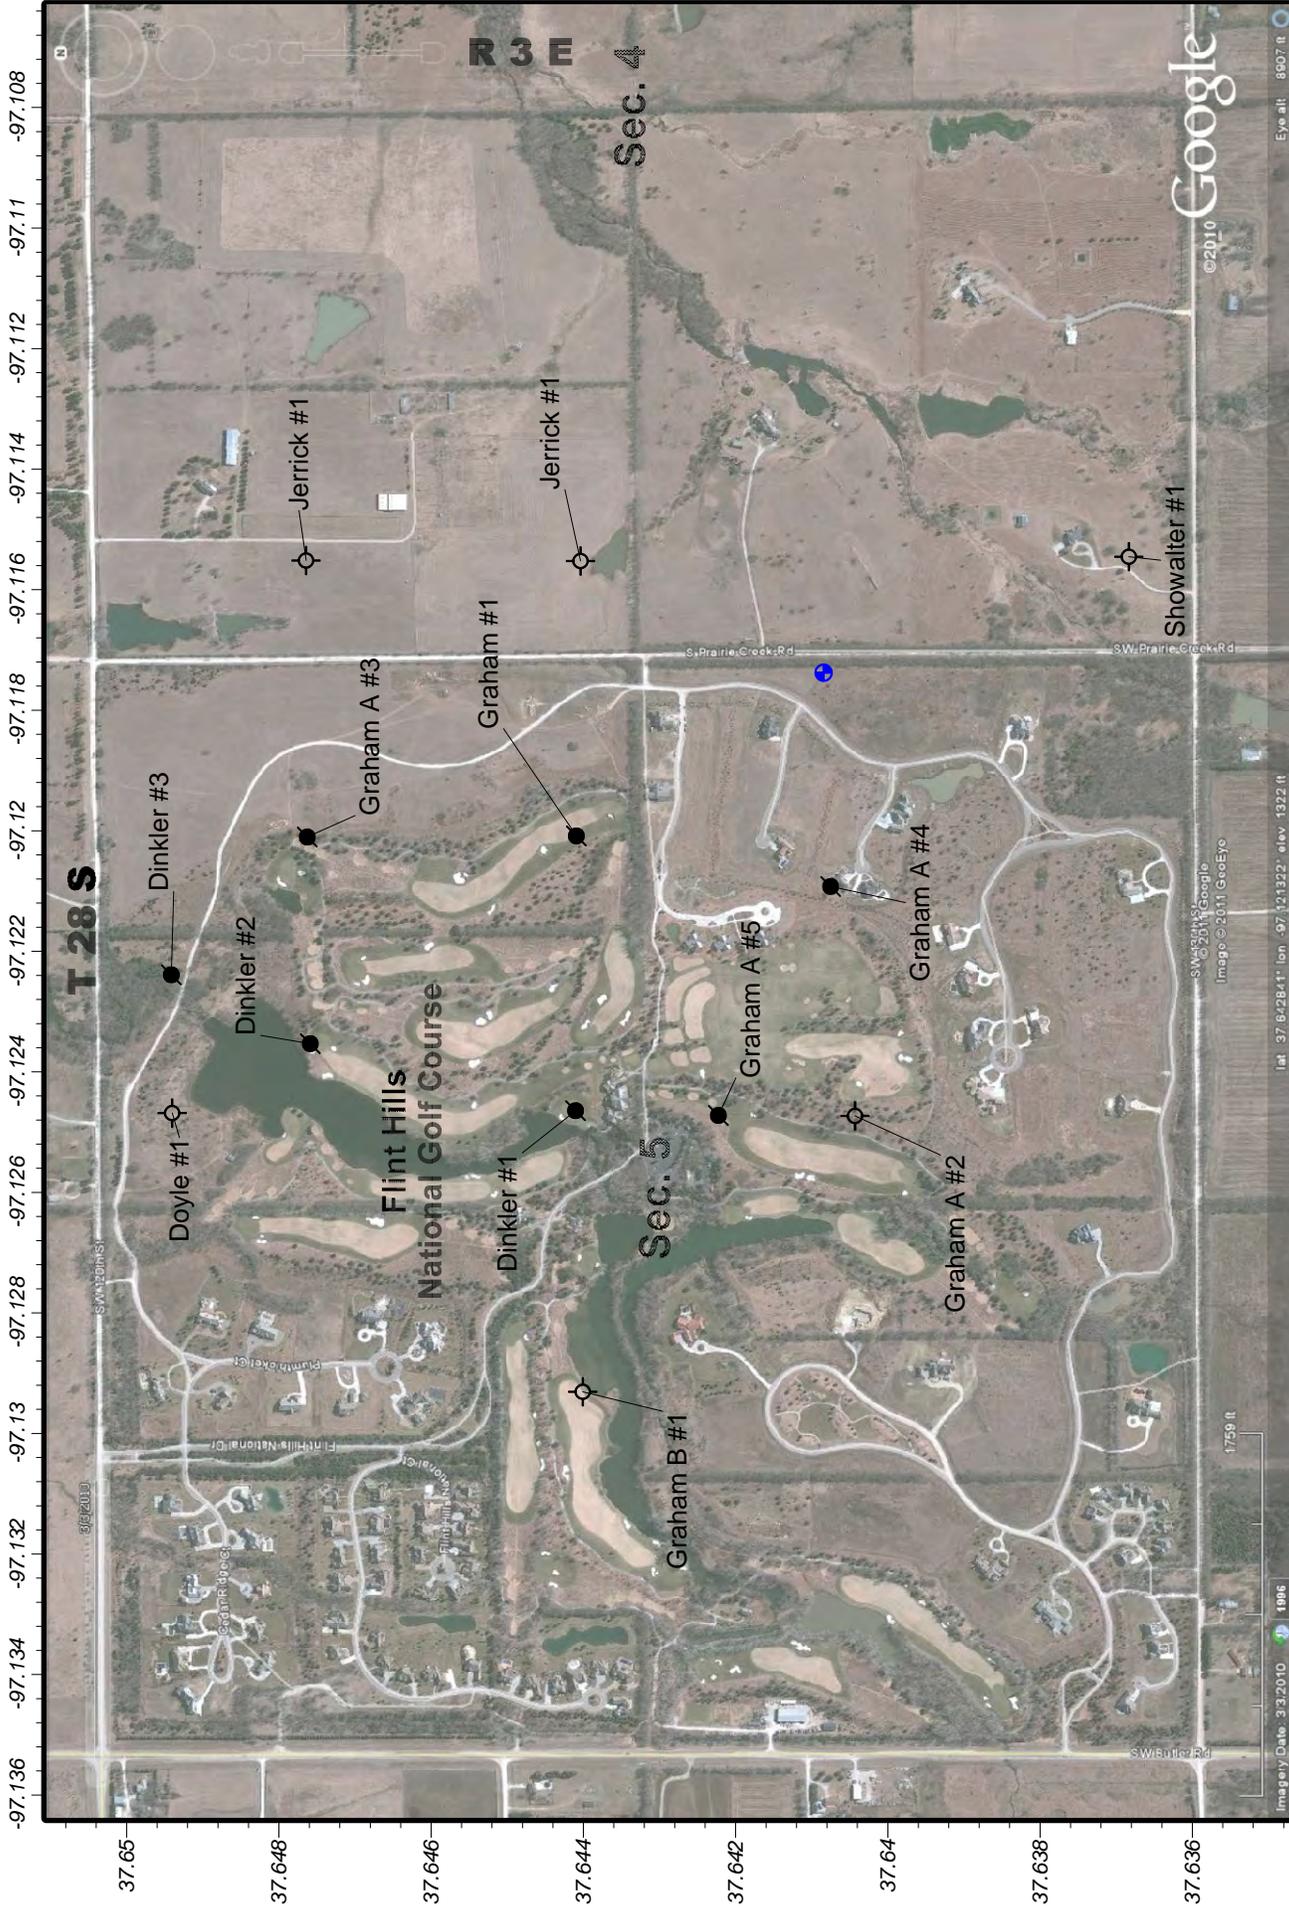
Dinkler/Flint Hills National Contamination Site
 Sections 4 & 5 of T 28 S & R 3 E of Butler County, Kansas
Site Map 2014
 KCC Code# 200050047-001 - District #2 - D. Bollenback - 11/20/2014

Unusual Problems: During the construction of a house on golf course property the surface casing for Graham No. 4 was encountered and oil was found in the casing. A rig was moved in and the well was replugged. Due to the problem encountered with well Graham No.4, Graham No.1 and No. 5 were located with a metal detector on the golf course (2006). Due to the exclusiveness of the golf course and real estate, plugging the unplugged oil wells and adding additional Monitoring wells would be difficult.

Status of Project: In the winter of 2005-2006 unplugged wells identified as the Graham #4 and the Dinkler #2 were plugged by the KCC. Three monitoring wells were installed down gradient to the plugged wells to evaluate water quality. Annual sampling has historically been done on these very low yielding wells. MW #1 was found to have an obstruction approximately 60' down and a decay odor. It appears that a small animal has fallen down the well and become stuck rendering this well unusable. 2014 The shallow zone well was found to be heaved and broken. Wells were not sampled during the 2014 summer.

Recommendation for Future Work: Two out of the three KCC monitoring wells have been rendered unusable. The wells are at the same location so very little data can be gained from them as far as the extent of any brine contamination. Over the last two to three years many houses have installed geothermal and other water wells to the west of the monitoring well battery. There have been no complaints registered with the KCC regarding brine impaction on these wells to date. Due to the exclusive nature of this site, requests for access to perform investigative borings may prove problematic. KCC recommends placing this site in the closed site list. KCC should plug out the three monitoring wells and restore the area to its original condition.

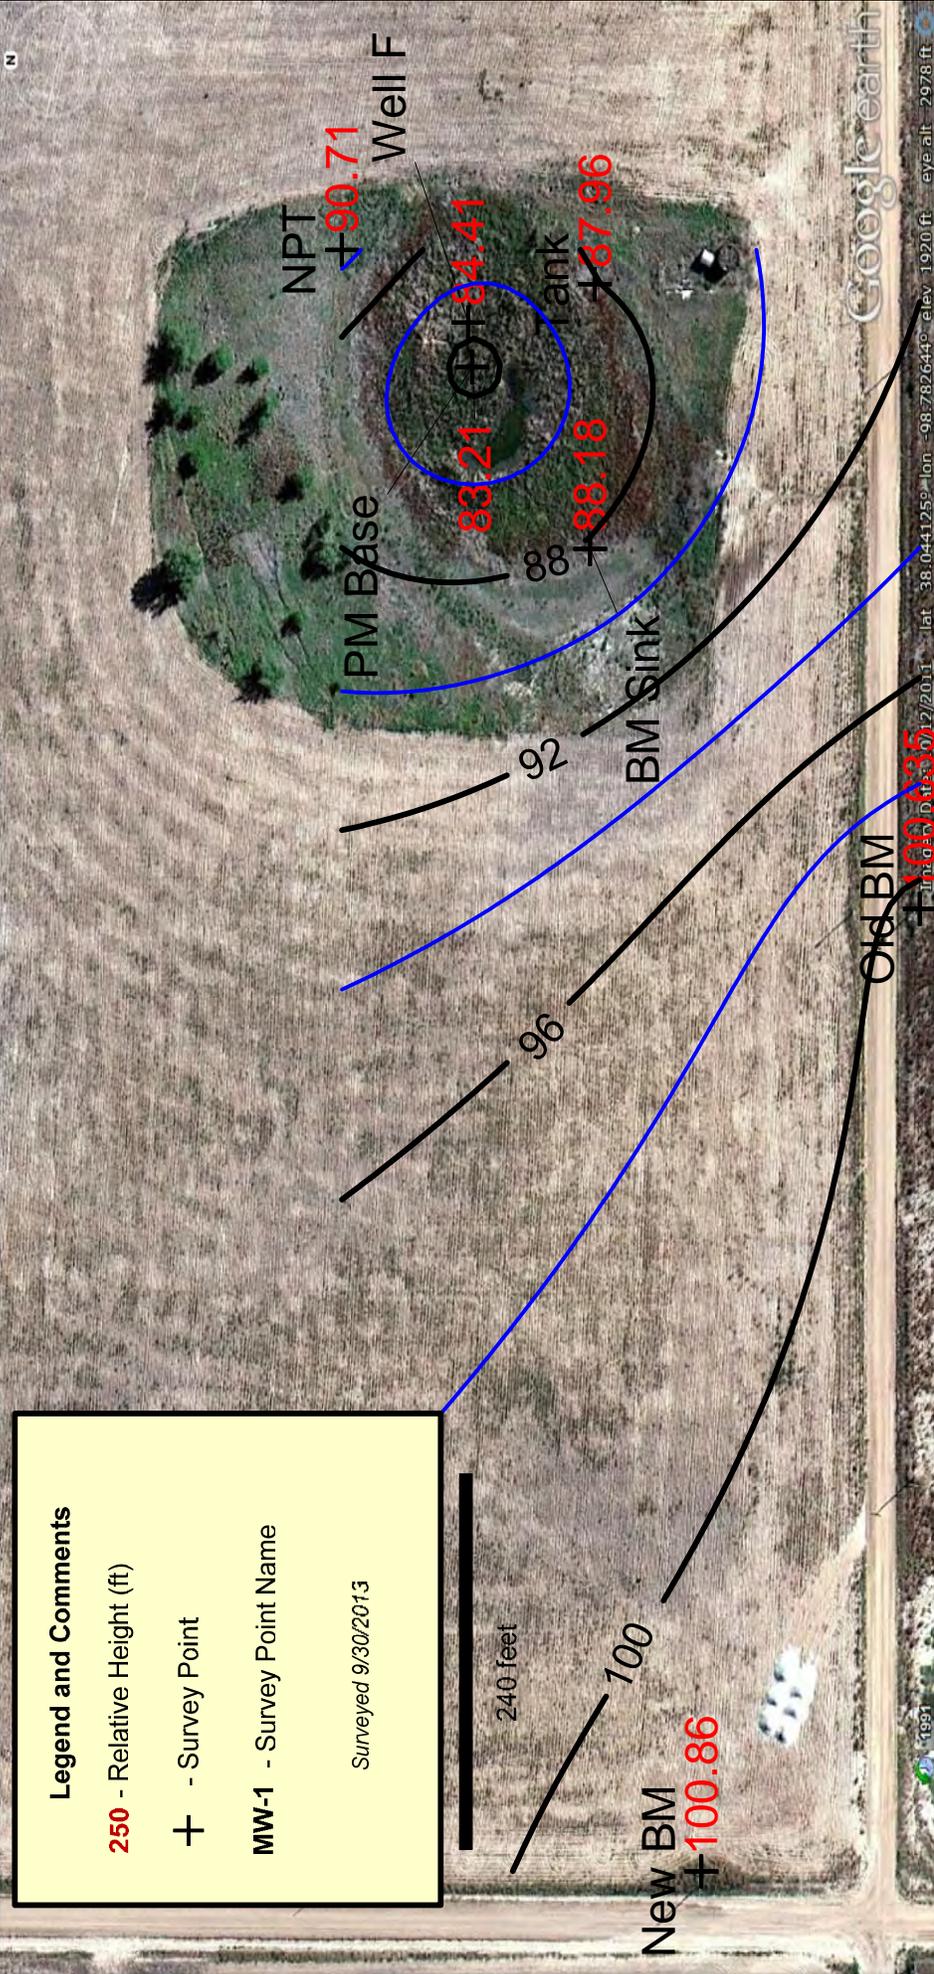
French Sinkhole

SW/4 Section 17-T23S-R13W
Stafford County, Kansas

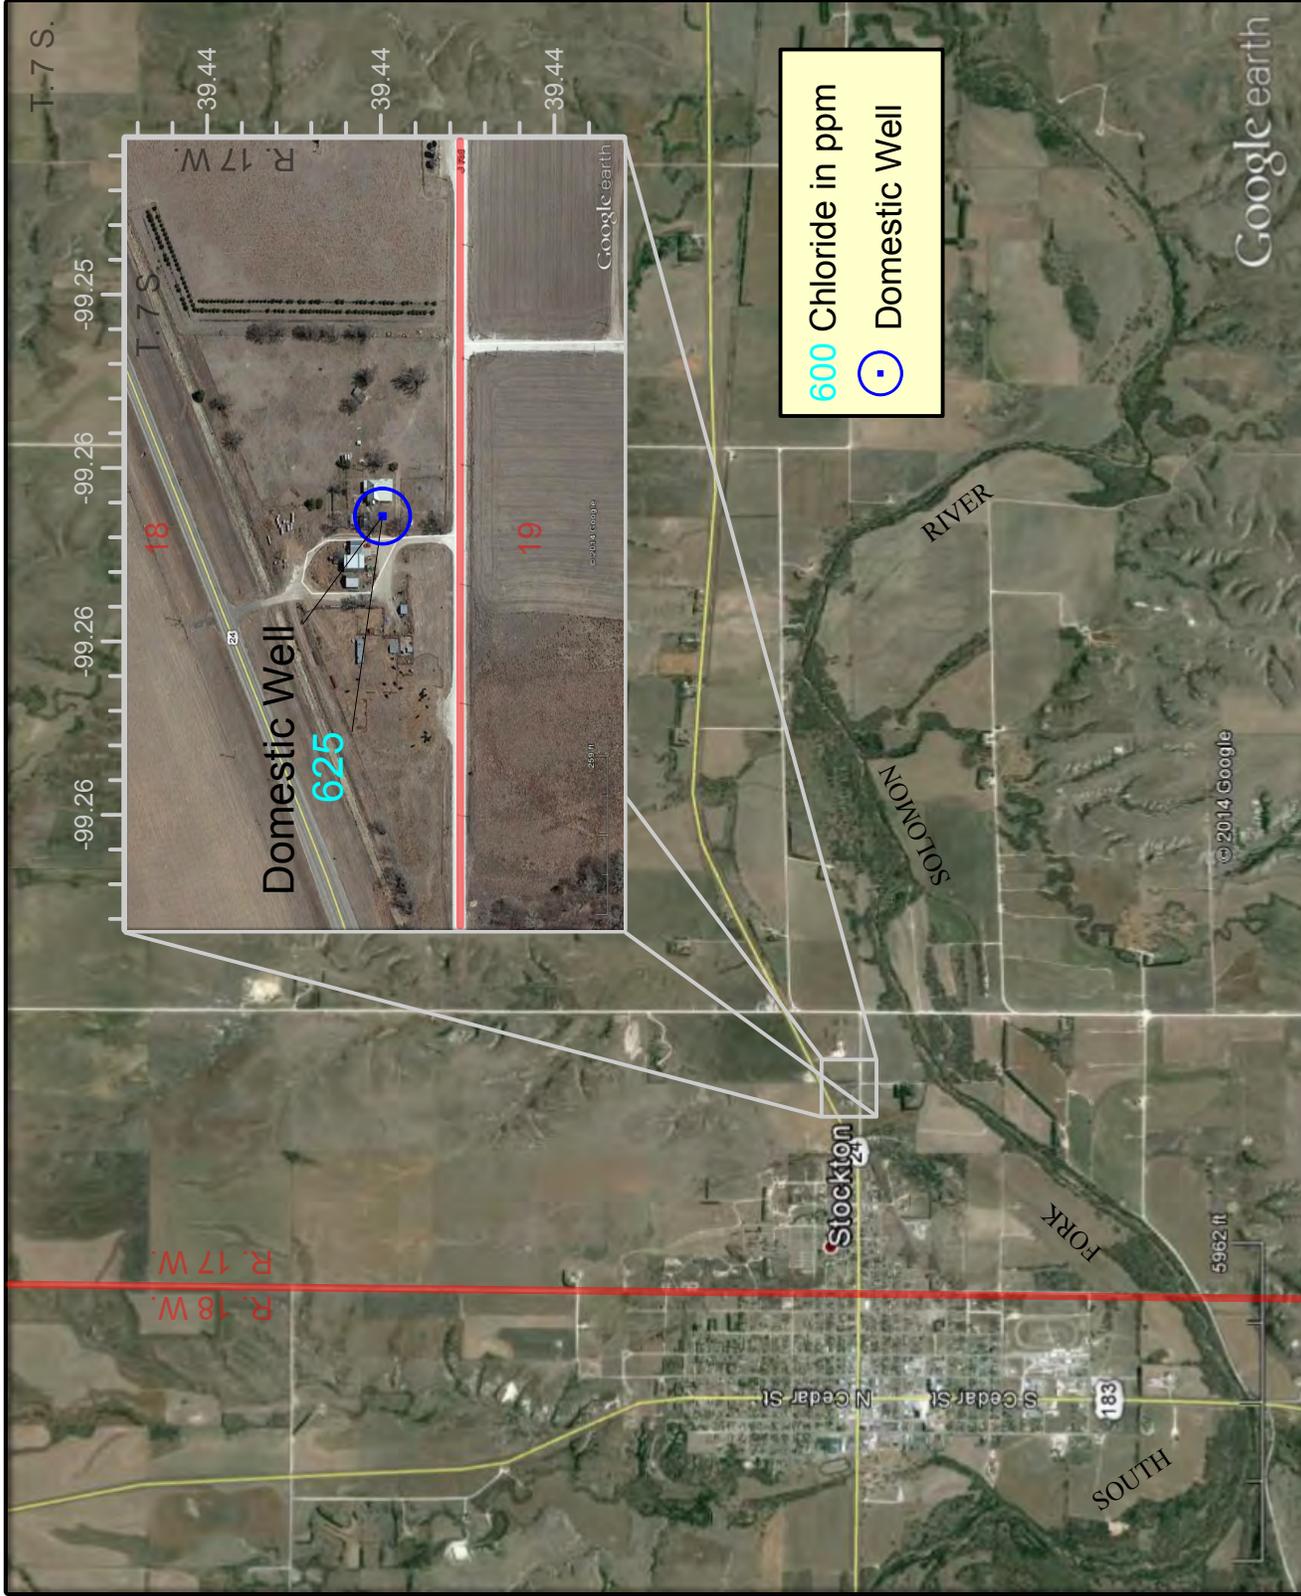
Schruben-Rogers Groundwater Monitoring Site

Section 18, Township 7 South, Range 17 West, Rooks County, Kansas
 2014 Groundwater Chloride Levels
